**Flood Control Project Maintenance
Levee Inspections**

Maintenance Issue Types Only, Levee Inspection Report By Mile - Fall 2016

Reclamation District No. 0001 Union Island

Waterway	Bank	Unit Miles	Inspection Start/End	Inspector
Unit No. 01 Old River	Right	1.14	10/13/2016 10/13/2016	Maksim Khashchuk

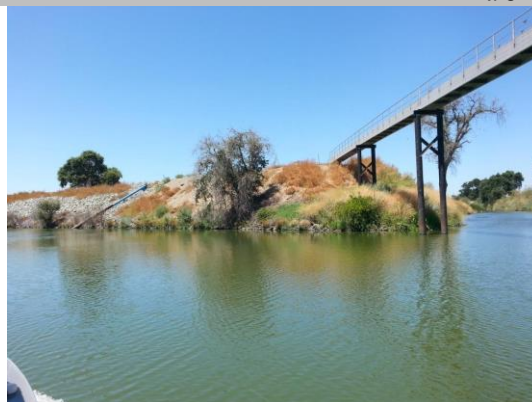
Photo 1 of 3 : SJR2016_RD0001U01RM31.4_1.jpg

LM Start	0.00	Rating **	M	Issue No.	1
LM End	0.00	Issue Type +	Ma	Location *	WS
Category	Supplemental		GPS Latitude/Longitude		
			Start	End	
Item	DWR Erosion Survey		37.822306°	37.822306°	
			-121.375304°	-121.375304°	
DWR ID					
Comment Code					
Inspector Comment					
07/25/2016: No significant change observed. 06/25/2015: No significant change observed. 07/02/2014: No significant change observed. 08/20/2013: No significant change at this site. 08/07/2012: The erosion is at the confluence of Old River and one of its tributary. [2016 Site ID:RD0001U01RM31.4]

Upstream view of the erosion.

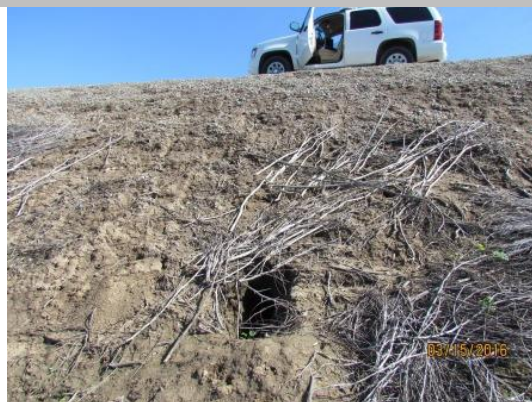
Photo 1 of 1 : FA_2016_RD0001_23_10_20160914_00007.jpg

LM Start	0.45	Rating **	U	Issue No.	10
LM End	0.45	Issue Type +	Ma	Location *	LS
Category	Earthen Levee			GPS Latitude/Longitude	
				Start	End
Item	Animal Control			37.818753 °	37.818753 °
				-121.380249 °	-121.380249 °
DWR ID	DWR_RD0001_01_s_2016_10				
Comment Code					
A3 : No rodents visible, but rodent burrows visible; need to backfill and compact or grout burrows.					
Inspector Comment					
Backfill and compact levee slope with acceptable levee fill.

View of the large rodent hole on the landside levee slope.

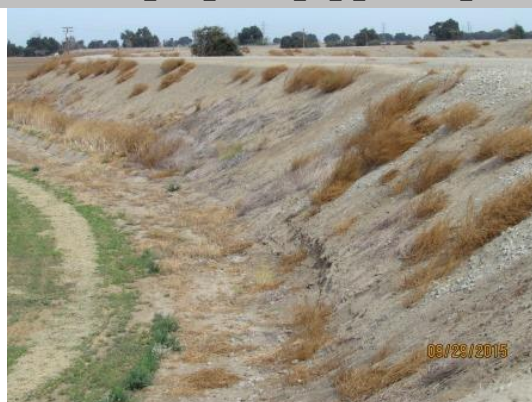
Photo 1 of 1 : FA_2016_RD0001_23_5_20160914_00005.jpg

LM Start	0.51	Rating **	M	Issue No.	5
LM End	0.51	Issue Type +	Ma	Location *	LS
Category	Earthen Levee			GPS Latitude/Longitude	
				Start	End
Item	Slope Stability			37.818003 °	37.818003 °
				-121.379845 °	-121.379845 °
DWR ID	DWR_RD0001_01_f_2015_5				
Comment Code					
S1 : Repair slope instability.					
Inspector Comment					
About a 1 ft. vertical cut is observed at the landside levee toe. Repair the landside levee toe per O&M standards.

View of the vertical cut at the landside levee toe.

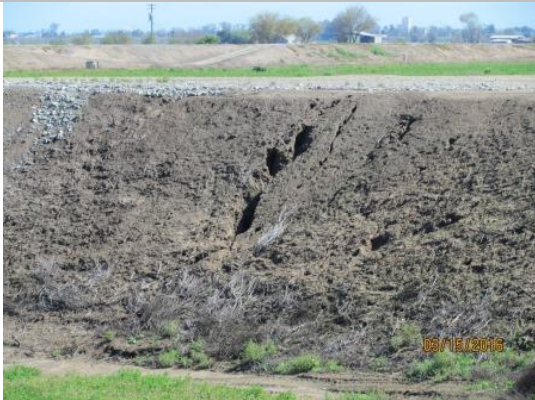
Photo 1 of 1 : FA_2016_RD0001_23_7_20160914_00006.jpg

View of the erosion on the landside levee slope.

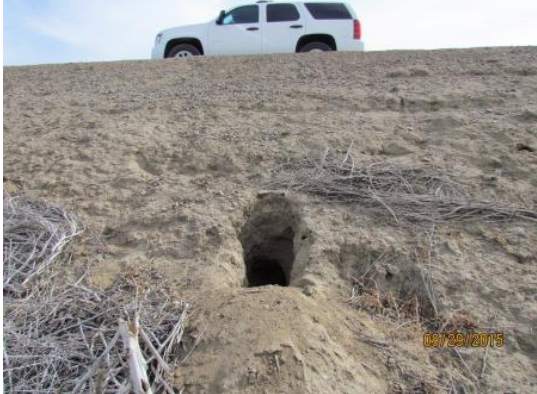
Photo 1 of 1 : FA_2016_RD0001_23_4_20160914_00004.jpg

View of a large rodent hole on the landside levee slope.

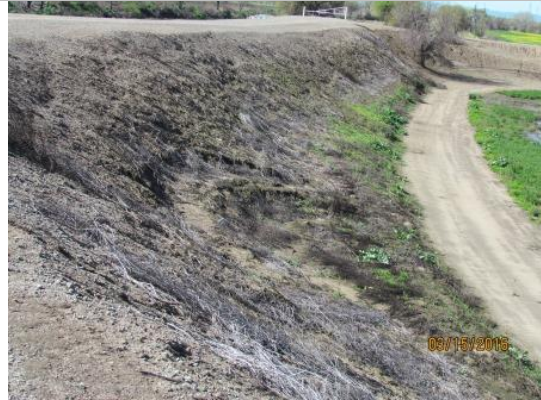
Photo 1 of 1 : FA_2016_RD0001_23_3_20160914_00003.jpg

LM Start	1.08	Rating **	M	Issue No.	3
LM End	1.08	Issue Type +	Ma	Location *	LS
Category	Earthen Levee			GPS Latitude/Longitude	
				Start	End
Item	Slope Stability			37.812023 °	37.812023 °
				-121.383961 °	-121.383961 °
DWR ID	DWR_RD0001_01_s_2016_3				
Comment Code					
S3 : Repair the levee slope damaged by vehicle traffic and prevent access where possible.					
Inspector Comment					
Repair slope damaged by vehicle by placing and compacting acceptable levee material.

View of the landside slope damaged by farm equipment.
